State of Nevada
Department of Health & Human Services
Division of Child & Family Services
Southern Nevada Child & Adolescent Services
Facility Condition Analysis

SOUTHERN NEVADA CHILD & ADOLESCENT SERVICES

6171 West Charleston Blvd.
Las Vegas, Nevada 89146

Site Number: 9991
STATE OF NEVADA PUBLIC WORKS DIVISION
FACILITY CONDITION ANALYSIS

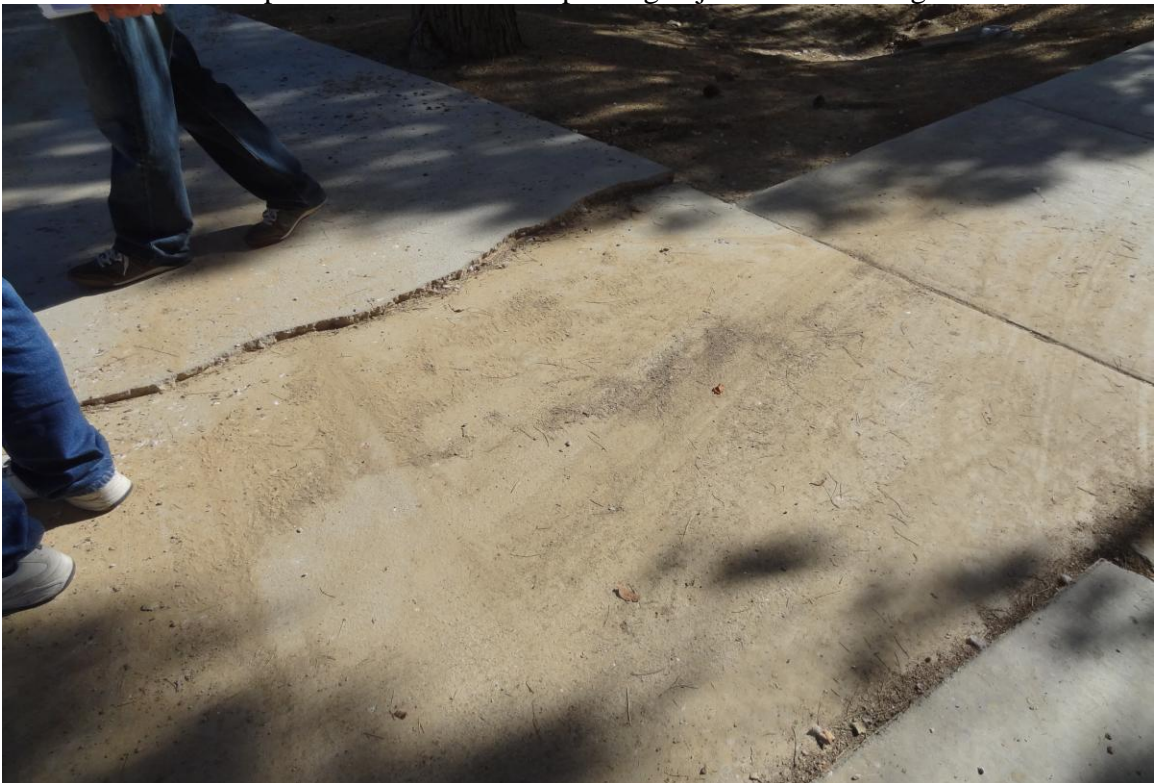
The Americans with Disabilities Act (ADA) provides for accessibility to sites and services for people with physical limitations. The concrete sidewalks around the site do not meet ADA requirements and are in need of repairs. Settling, spalling and cracking have created elevation changes or gaps that are non-ADA compliant. This project would provide for removing the damaged sections of concrete and replacing them with new concrete. 500 SF of 4" thick P.C. concrete sidewalk was used for this estimate. The 2012 IBC, ICC/ANSI A117.1 - 2009, NRS 338.180 and the most current version of the ADA Standards For Accessible Design were used as a reference for this project.

Southern Nevada Child & Adolescent Services Site – FCA Site #9991
Description: Damaged walkway, note tripping hazard.

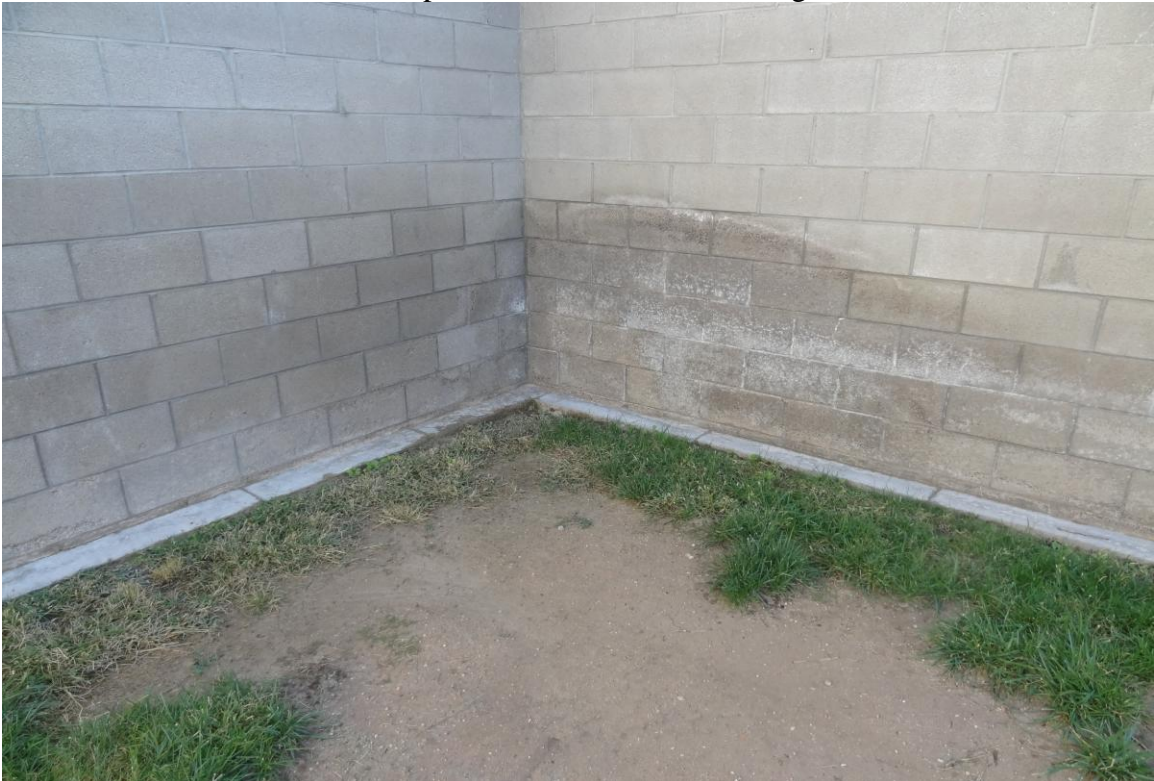
The building and courtyard walls have considerable damage to the concrete masonry units (CMU) from lawn sprinklers wetting the CMU and poor drainage. Four of the five courtyards are due to be re-worked in order to prevent further damage. This project would remove the turf within three feet of the CMU walls, adjust the sprinklers so they do not wet the walls and re-grade or install French drains to ensure proper drainage out of the courtyards.

Desert Willow Treatment Center – FCA Building #1994
Description: Water damage to CMU wall in courtyard.
